SEAVIEW SQUARE MALL
SUMMARY OF AIR SAMPLING

Fred C. Hart Associates, Inc.
530 Fifth Avenue
New York, NY 10036

Equitable Real Estate Management Co., Inc.
101 Park Avenue
New York, NY 10178

MAY 1986

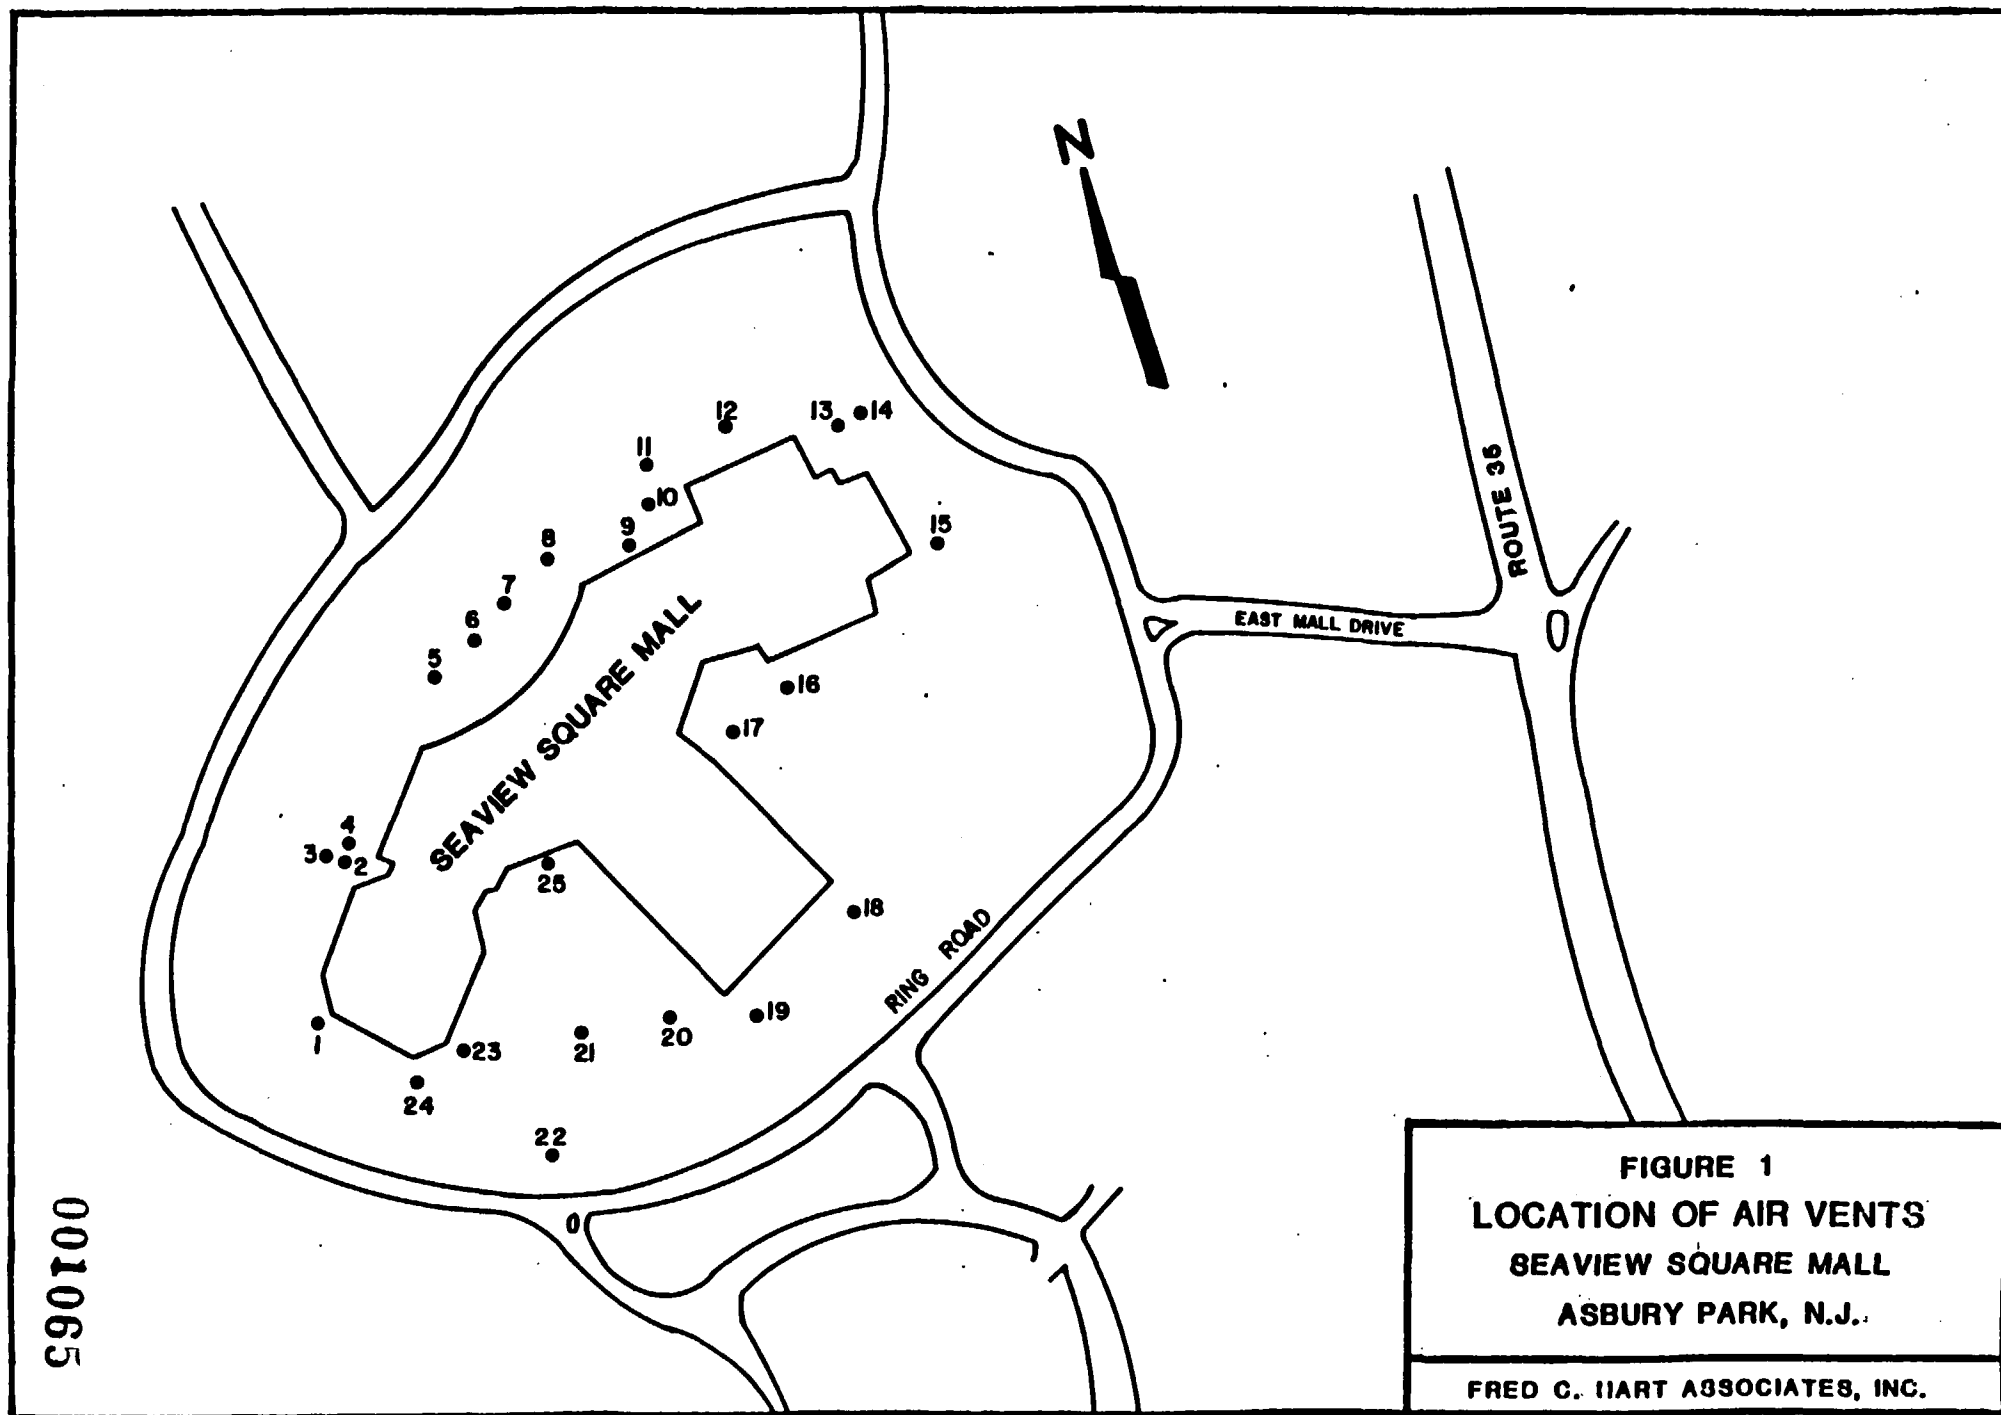
FIGURE 1
LOCATION OF AIR VENTS
SEAVIEW SQUARE MALL
ASBURY PARK, N.J.

Gas sampling was performed as part of the Remedial Investigation on November 22 and December 12, 1983. Due to problems in quality control, vent sampling was repeated on June 4, 1984. The initial sampling was performed on 25 existing vents and was used to determine the most active vents for further, more extensive, testing. The approximate location of the vents are shown in Figure 1.

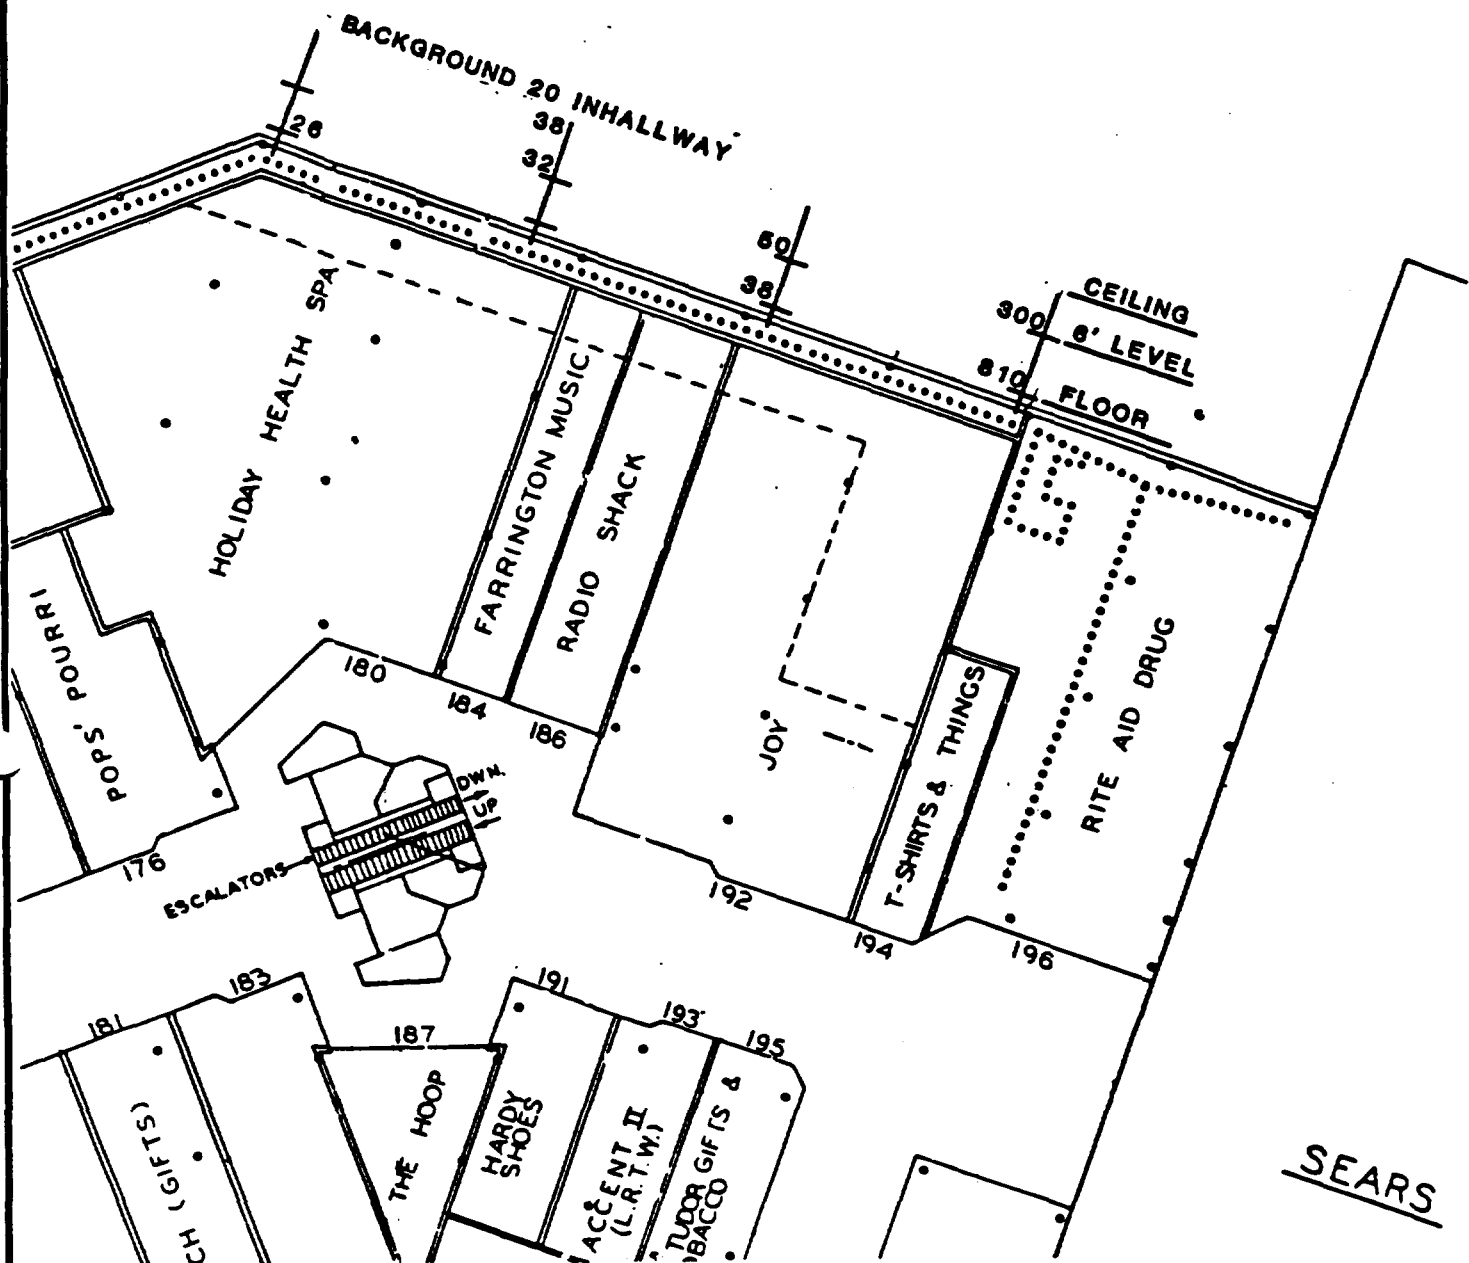
FIGURE 5
LOWER HALLWAY AND RITE AID DRUG
LFG SAMPLING 1/8/85
SEAVIEW SQUARE MALL
ASBURY PARK, N.J.

LFG levels were found to be at zero or ambient in all the areas surveyed except the hallway behind B. Daltons (300 ppm), room 145 (0 - 1000 ppm), the expansion joints in the hallway behind rooms 184-186-192 (0-850 ppm), near the Rite Aid delivery door (10 - 50 ppm), and Care on the Square (2.5 - 40 ppm). The data are summarized in Appendix A and shown in Figures 3, 4, 5 and 6.

20 PPM BACKGROUND LEVEL

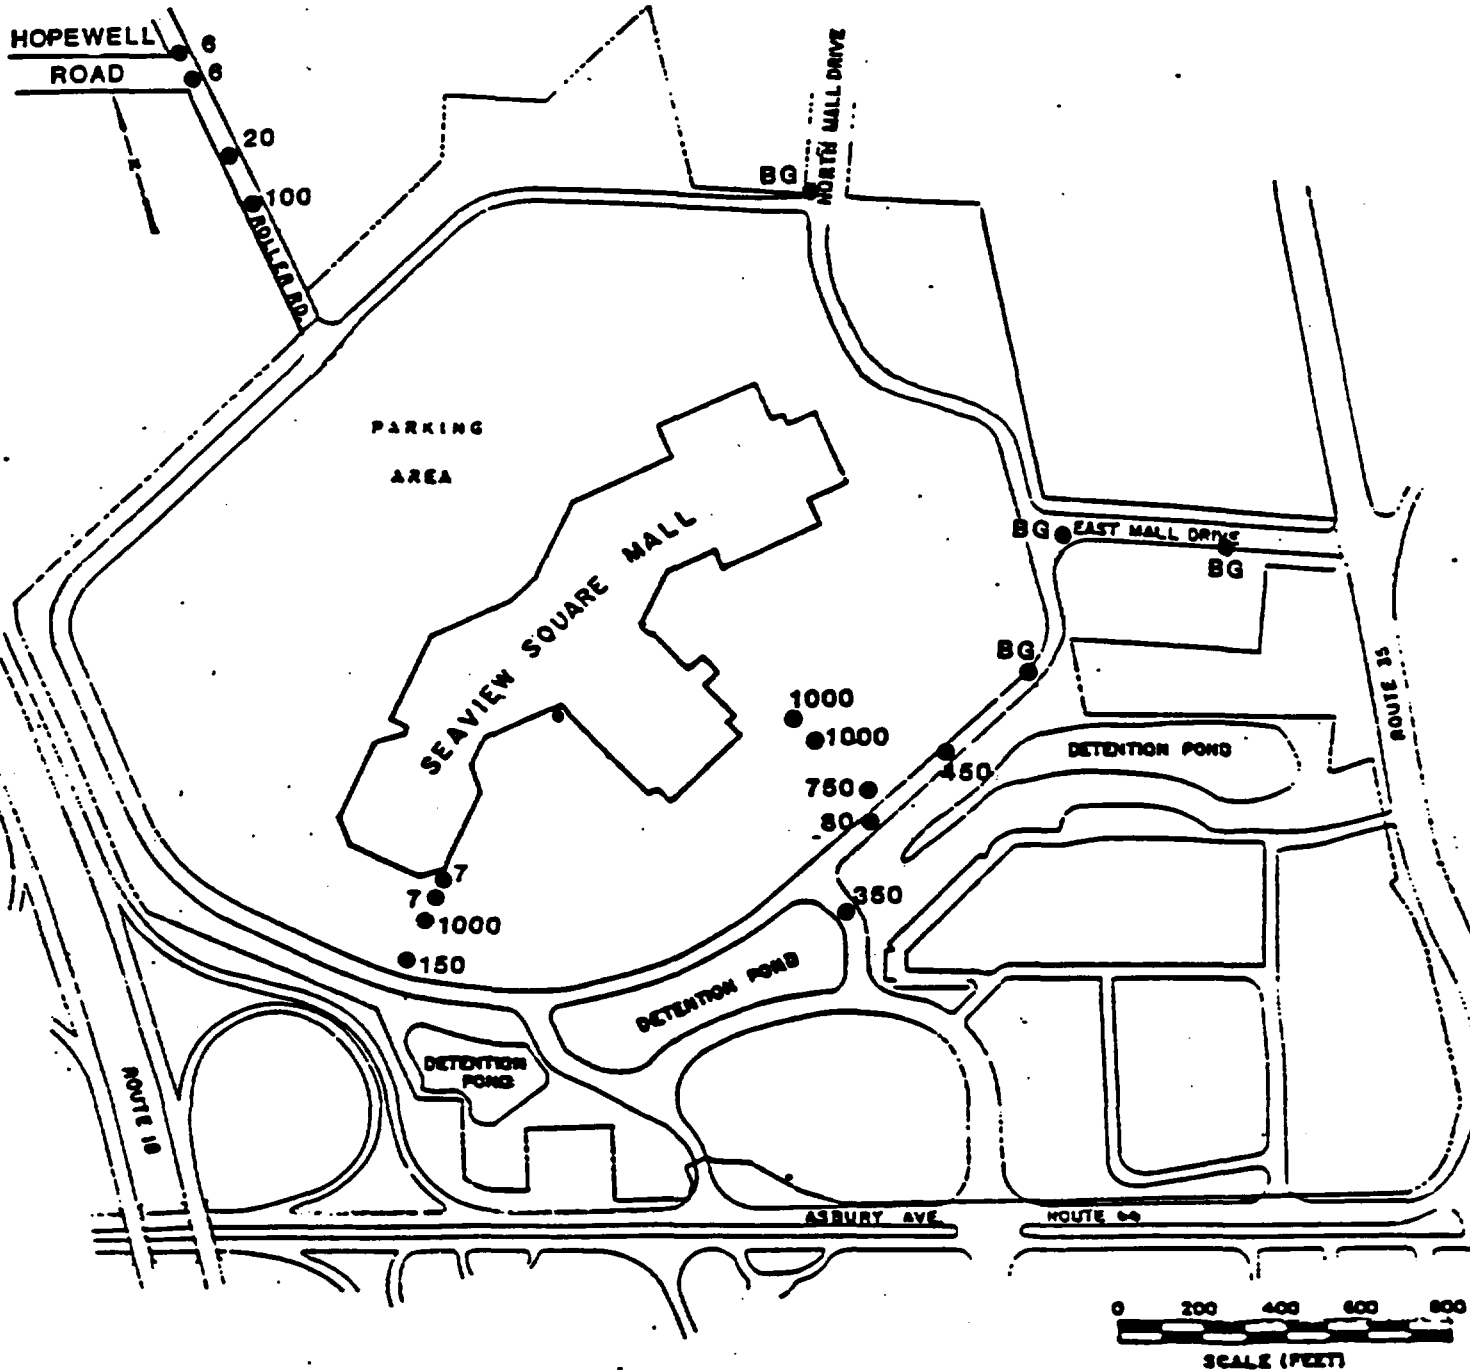
FIGURE 8
SUBSURFACE LFG SAMPLING
IN THE UTILITY CORRIDORS 1/9/85
SEAVIEW SQUARE MALL
ASBURY PARK, N.J.

On January 9, 1985, eighteen air samples were taken under the asphalt within the sewer, water and power utility corridors leading from the mall to the off-site utilities. The sewer utility corridors drain east to west on the south side of the mall and run under Roller Road and the south and western sections of Ring Road, and finally discharge off-site into the main sewer trunk under NJS Route 35. Water enters the mall building near Stern's and Thom McAnn's and ultimately connects to the water main under NJS Route 66. JCP&L supplies electricity via overhead lines. Power cables run underground near the property perimeter to aboveground electrical transformers adjacent to mall buildings. Results of sampling are provided in Figure 8 and Appendix B.

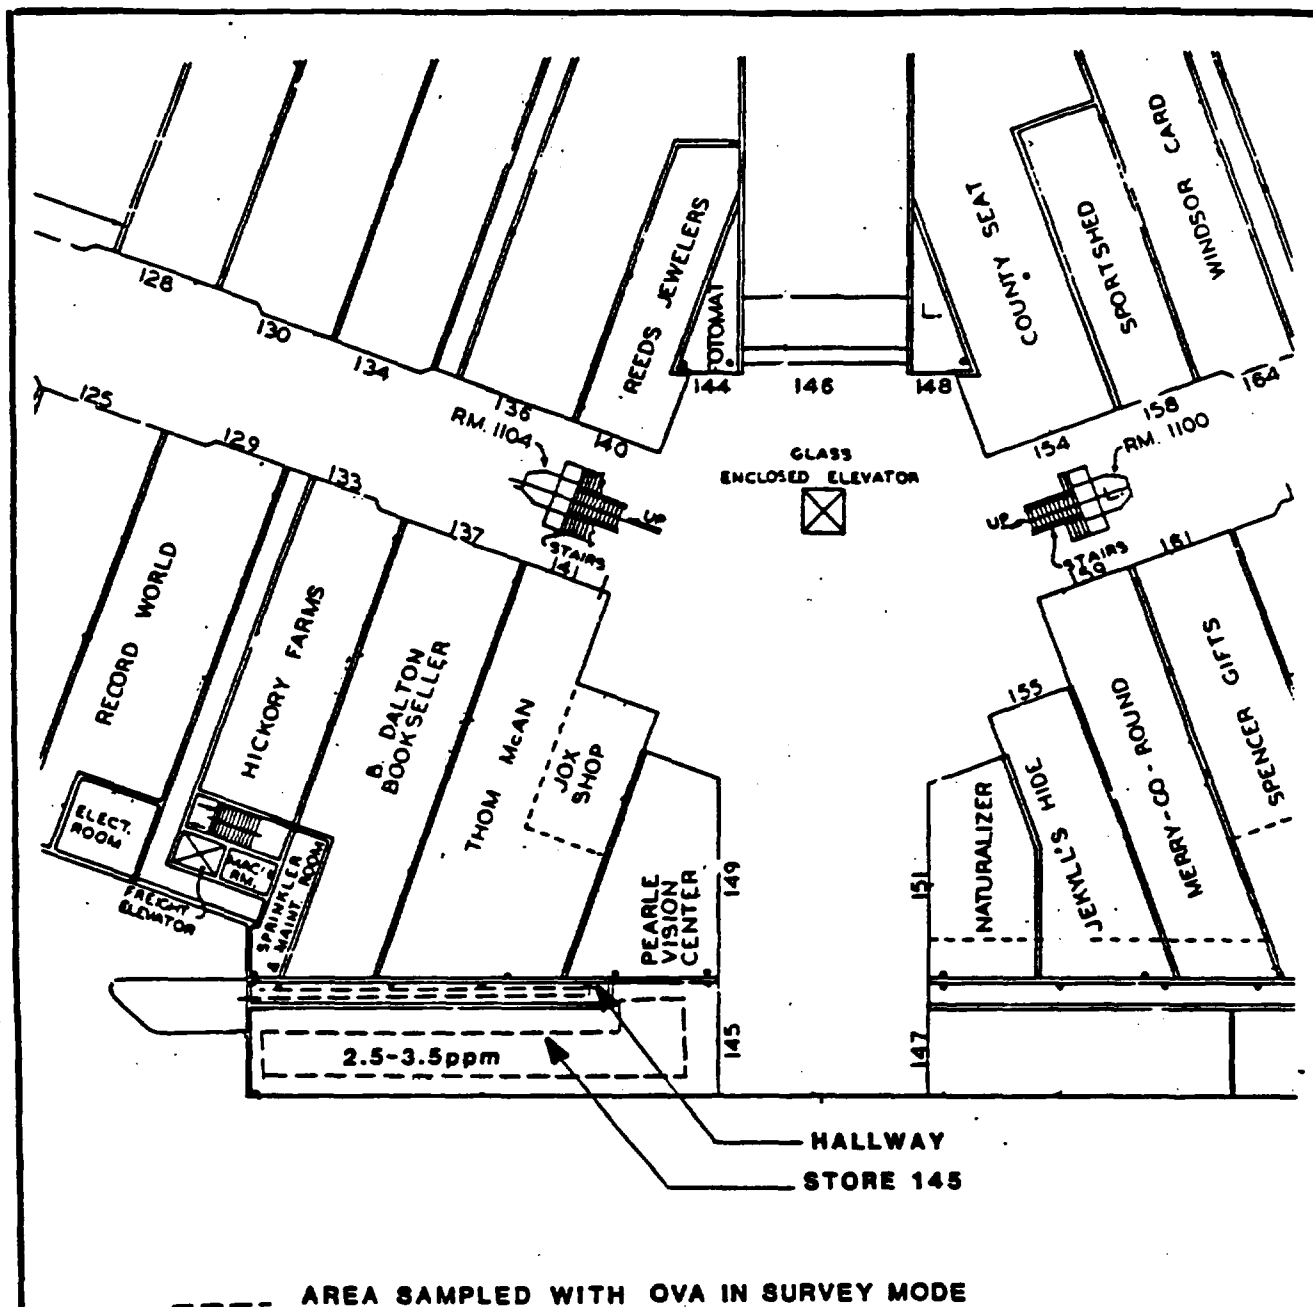
FIGURE 11

During the July and August surveys, LFG levels were found to be zero or ambient in all areas surveyed except: (1) the hallway adjacent to Store 145 and in Store 145 (see Figures 11, 12 and 13) and (2) the lower level hallway located behind stores #192 and #180 (see Figure 14). In addition, no LFG was detected in Care-on-the-Square (see Figure 15).

STORE 145 AND HALLWAY
LFG SAMPLING 7/9/85
SEAVIEW SQUARE MALL
ASBURY PARK, N.J.

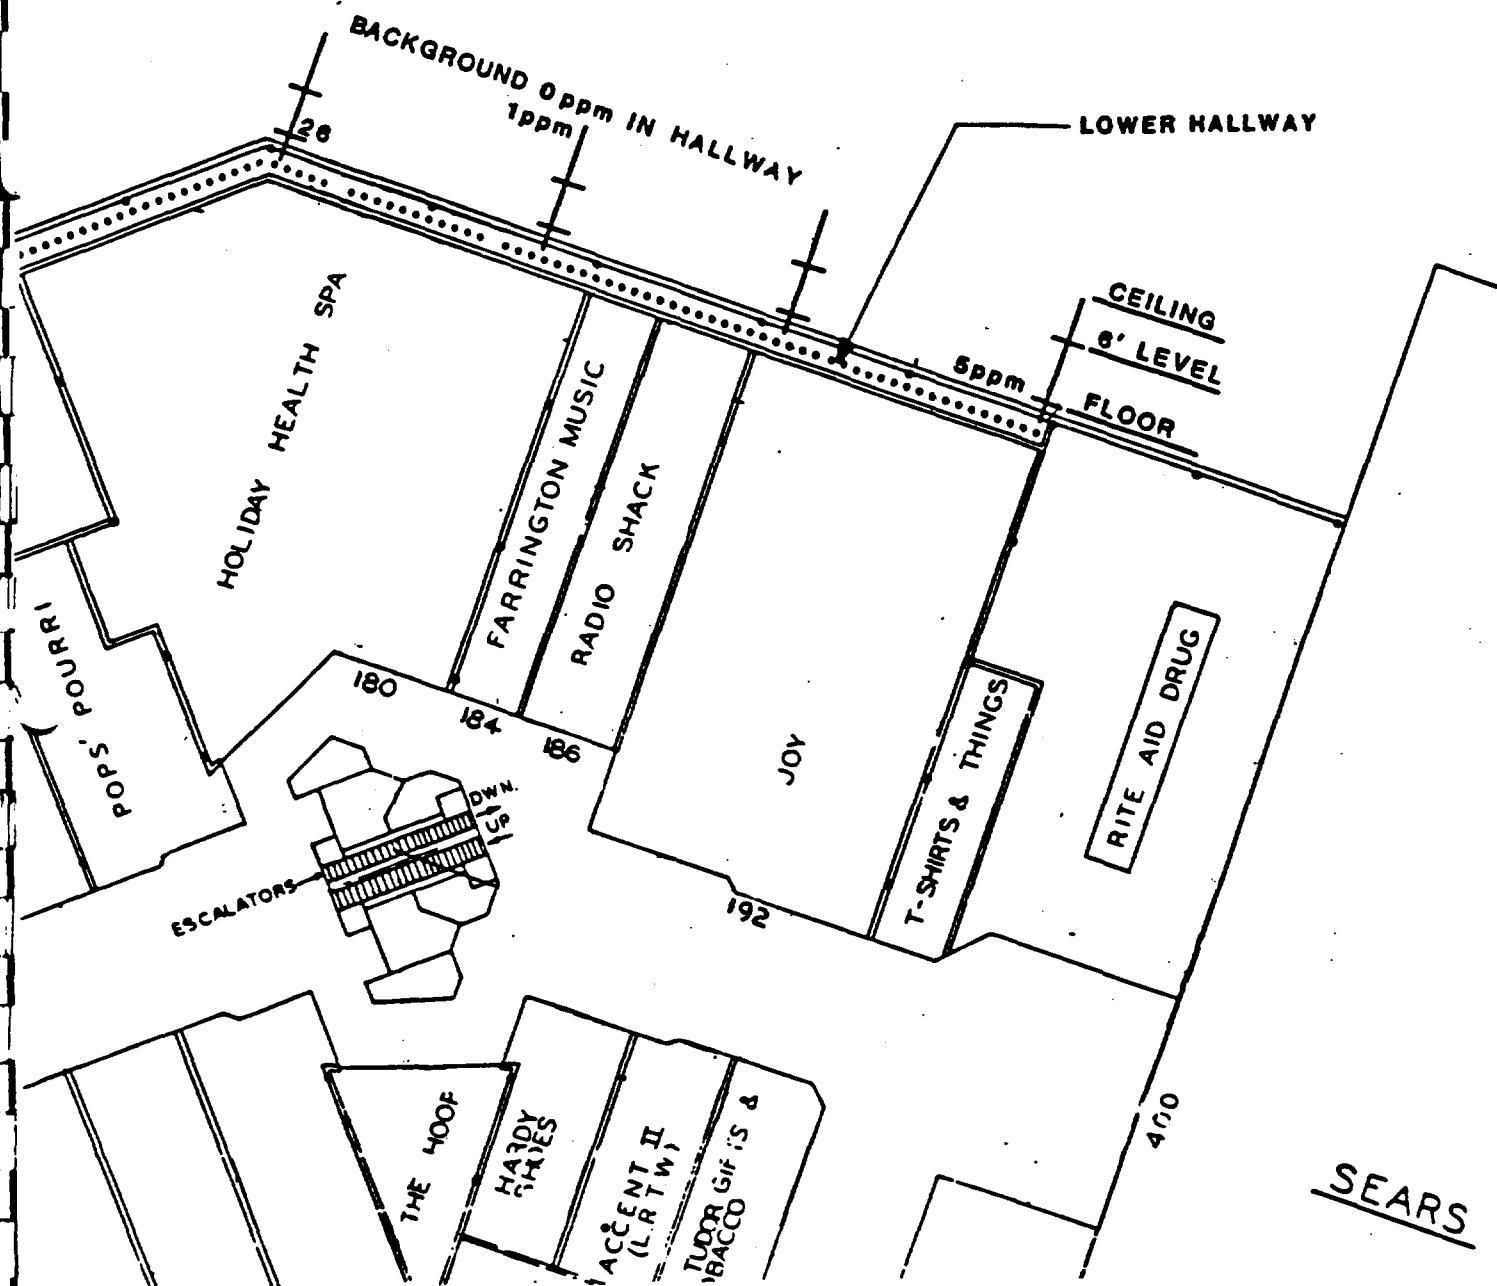
FIGURE 14
LOWER HALLWAY AND RITE AID DRUG
LFG SAMPLING 7/9/85 & 8/21/85
SEAVIEW SQUARE MALL
ASBURY PARK, N.J.

0 ppm BACKGROUND LEVEL (8/21/85)

No readings above background were
obtained on the 7/9/85 survey.
